# Defect Detection in Composite Materials by Thermographic Software

This research flyer demonstrates how thermographic inspection techniques and software analysis can detect defects in composite materials, particularly the highly relevant impact damage. Composite materials are increasingly being used for surface transport such as buses, trucks, trams and trains. The benefits of using composite materials over conventional materials like steel and aluminium are that they offer the potential for higher strength and stiffness together with superior corrosion immunity, lower weight and a reduction in cost. However, the materials and structures are non-homogeneous meaning that traditional monitoring and analyses are unsuitable for the detection, and characterisation, of composite defects. Composite materials are particularly susceptible to impact damage that may not be visible to surface inspection, hence, the importance of NDT techniques like thermography and the ability for thermographic software to detect defects.

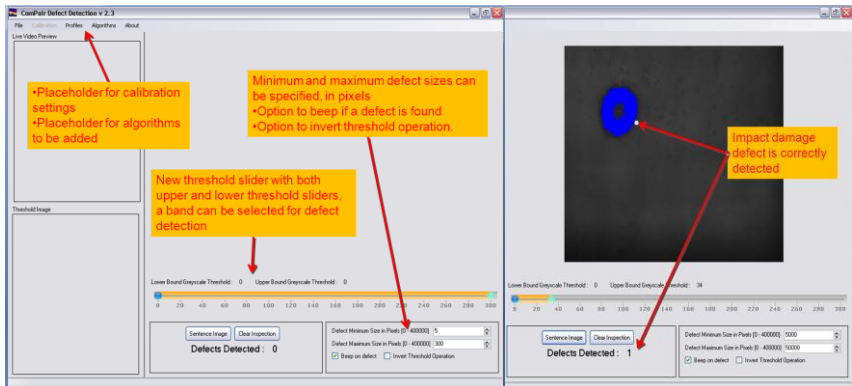
The software interface and functionality has been designed to assist engineering analysis of composite materials using thermographic techniques with a particular emphasis made to detect impact related defects. Impact related defects require algorithms to identify the particular greyscale band that characterises impact damage with a specific composite material. Hence, a greyscale threshold slider was developed that enabled selection of the target greyscale, the capture of this as a "Profile" and a pixel-defined area so a specific defect size can be identified. The KCC thermography software successfully detects defects caused by impact damage.

The screenshots above highlight the areas of interest in the newly developed user interface for the ComPair project in light of the data that are available at the present time and allowing for the development of future algorithms.
